**Before the
Federal Communications Commission
Washington, D.C., 20554**

DECLARATION OF JEFF BRITNELL

Photos in Support of Jeff Britnell Declaration

Guying and Anchoring Violations

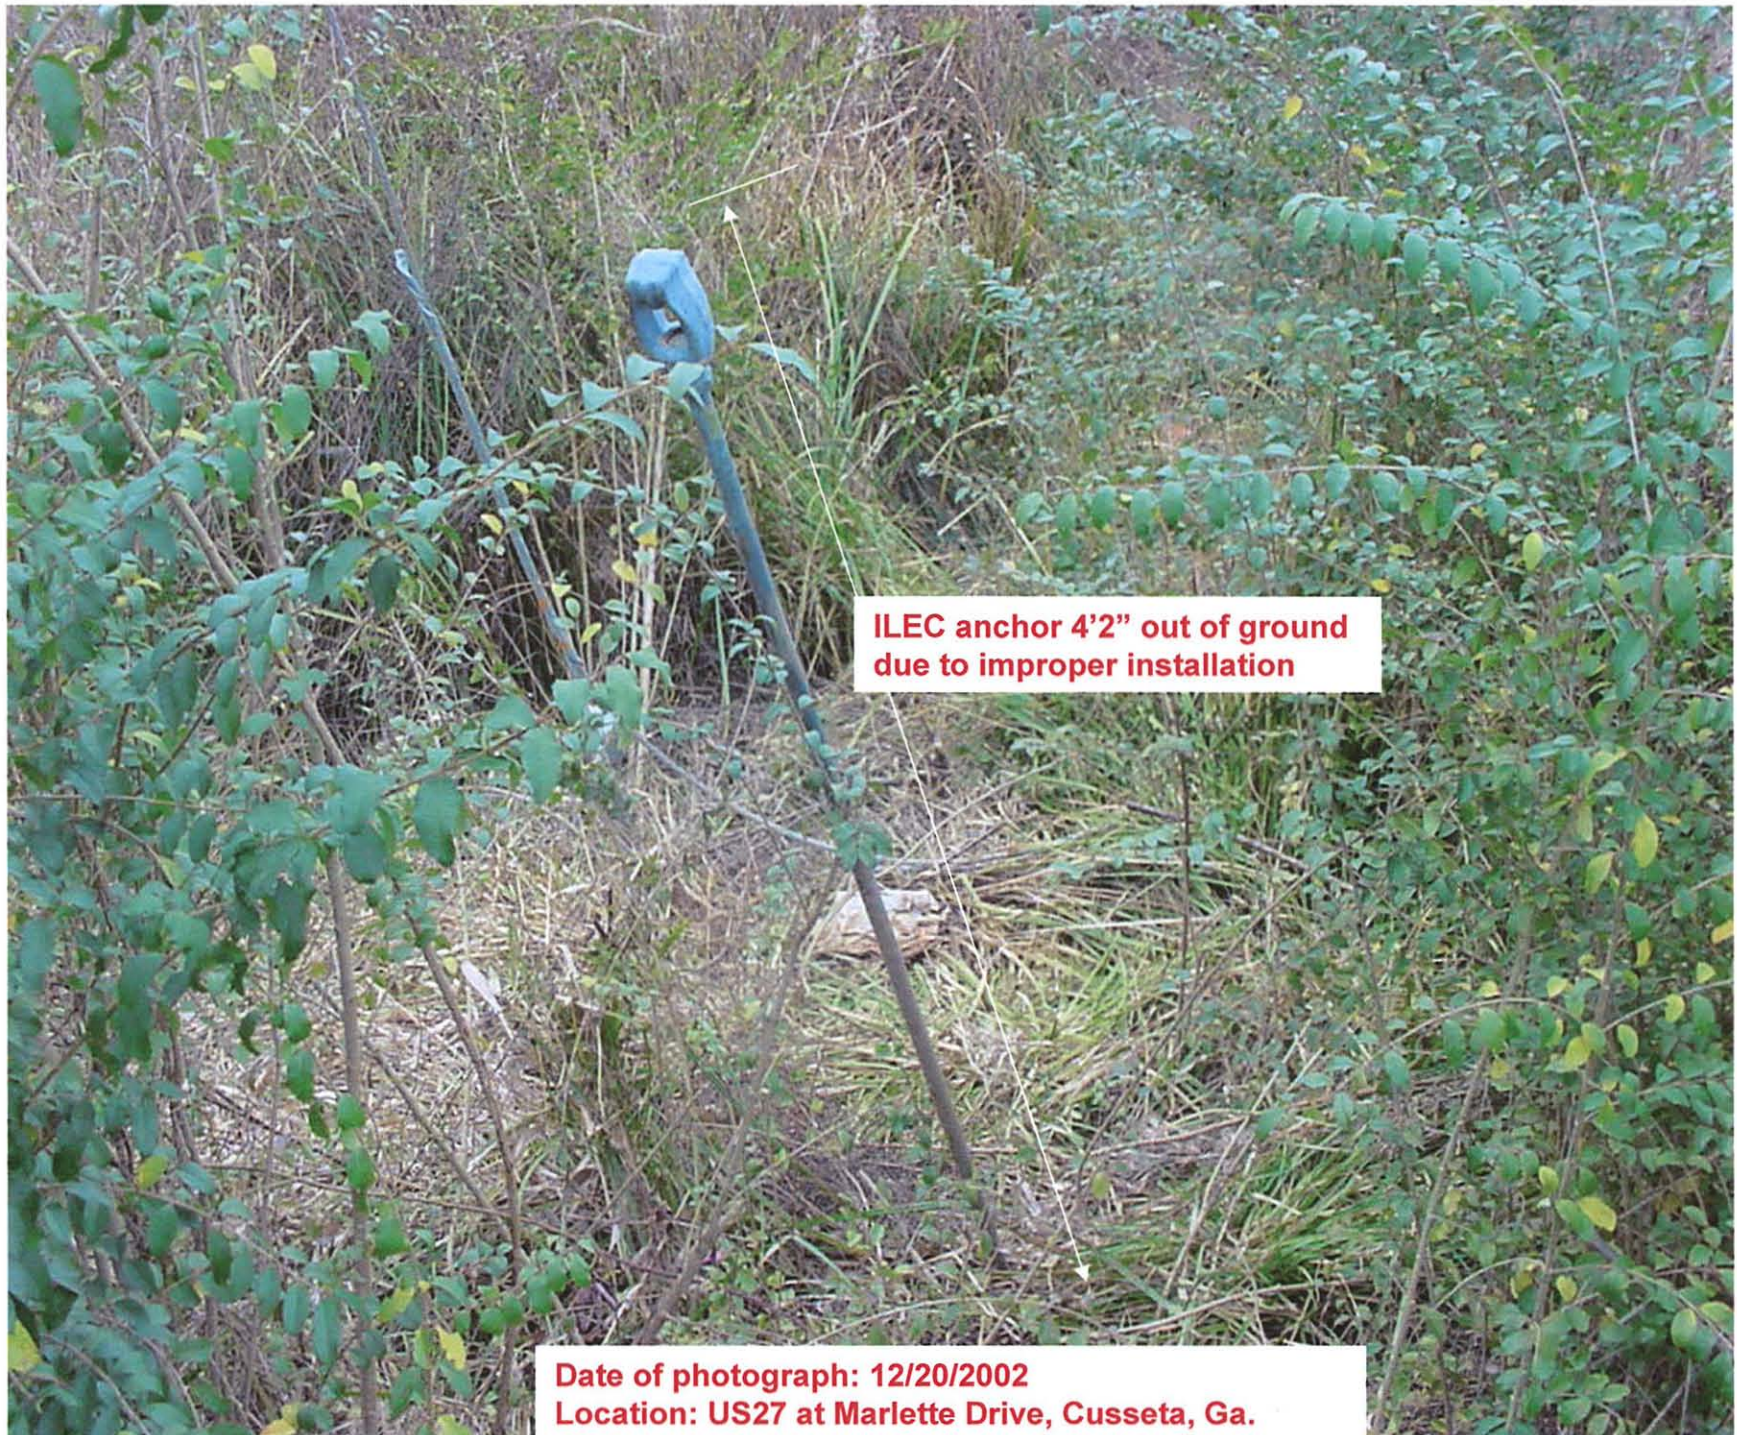
Date of photograph: 12/20/2002
Location: US27 at Marlette Drive, Cusseta, Ga.

ILEC anchor 4'2" out of ground
due to improper installation

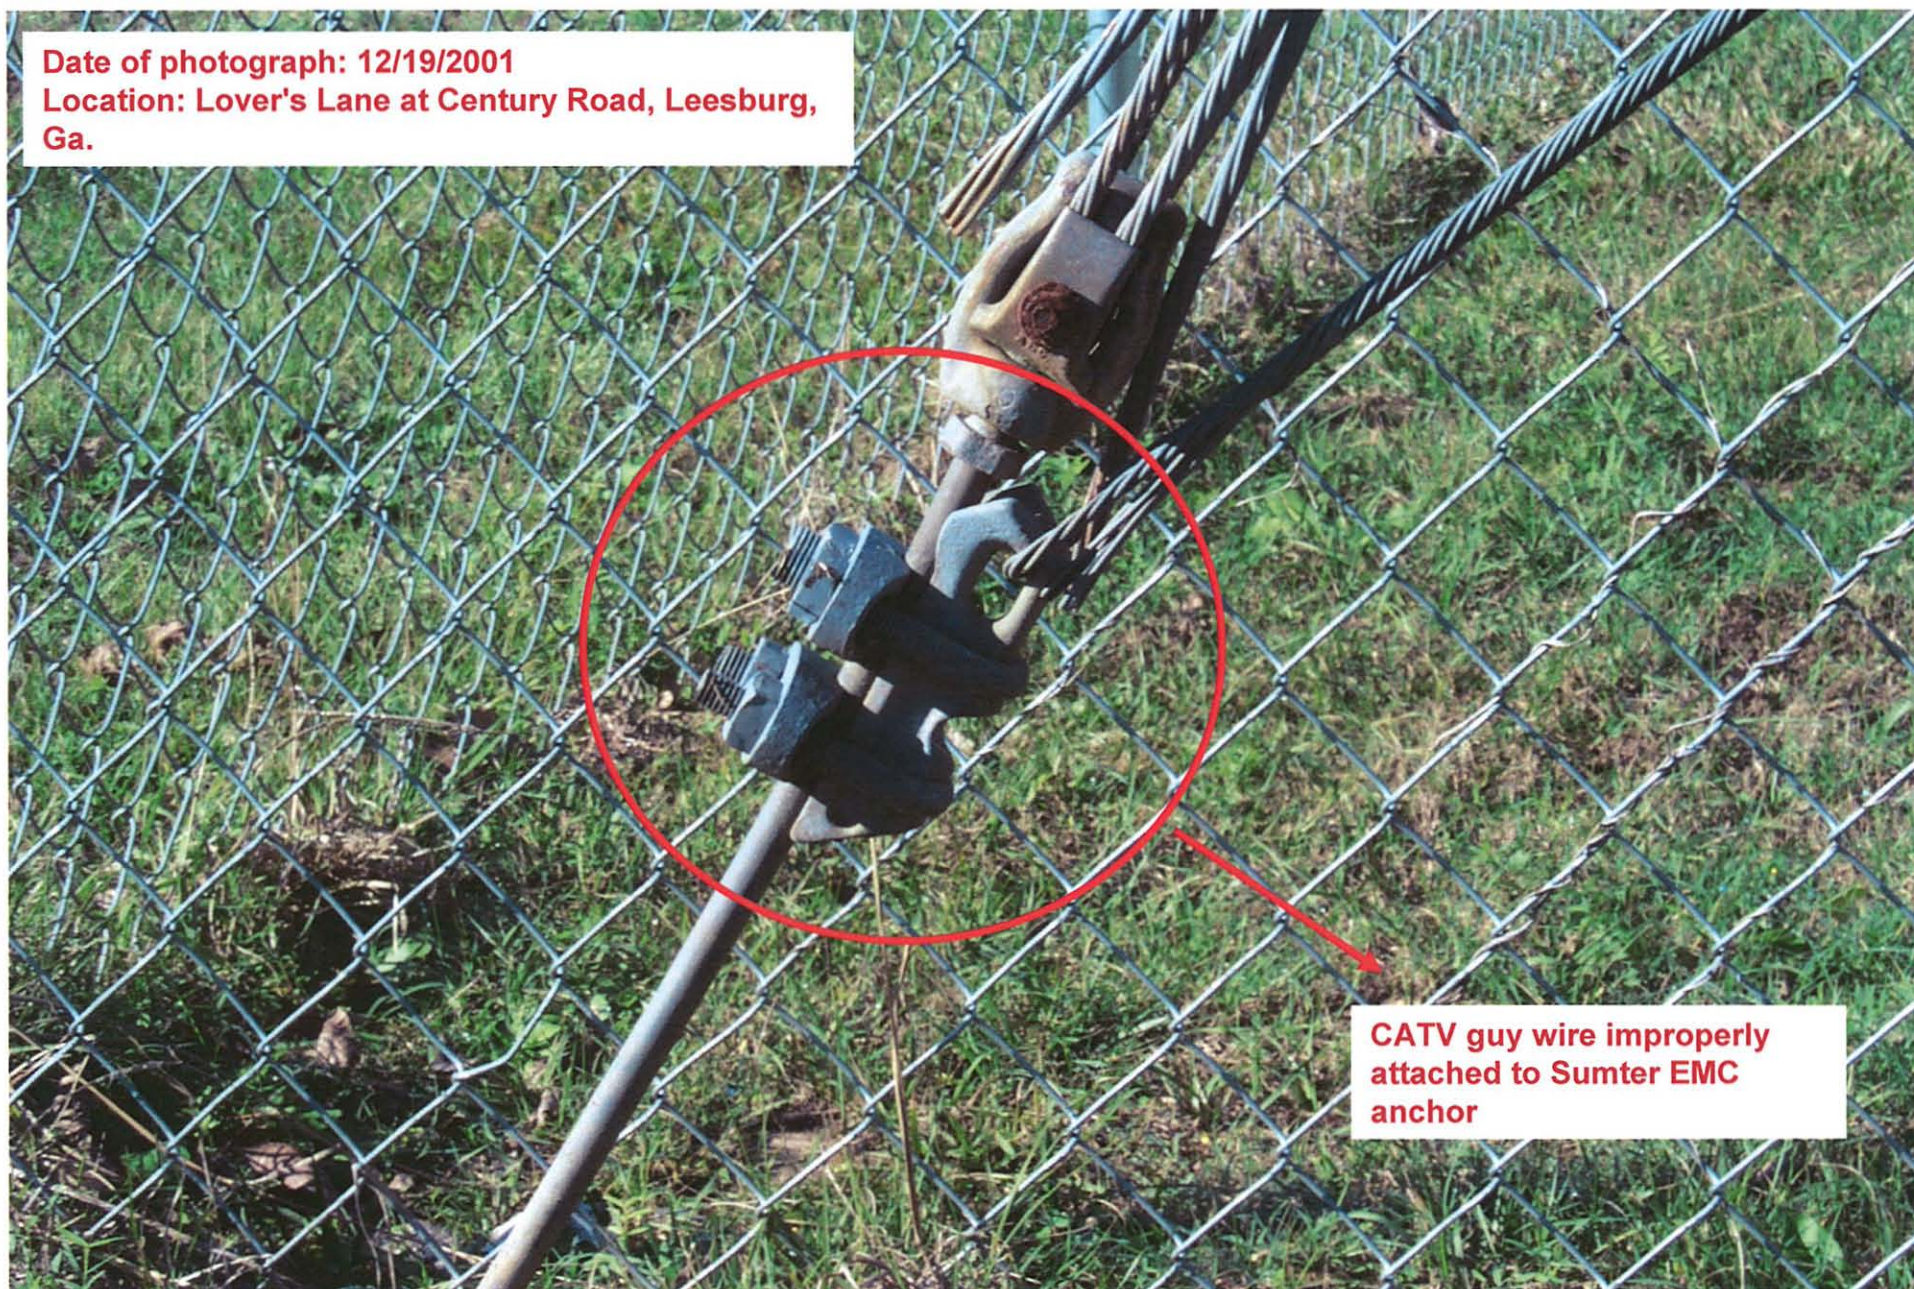
Date of photograph: 12/19/2001

**CATV guy wire improperly
attached to Sumter EMC
anchor**

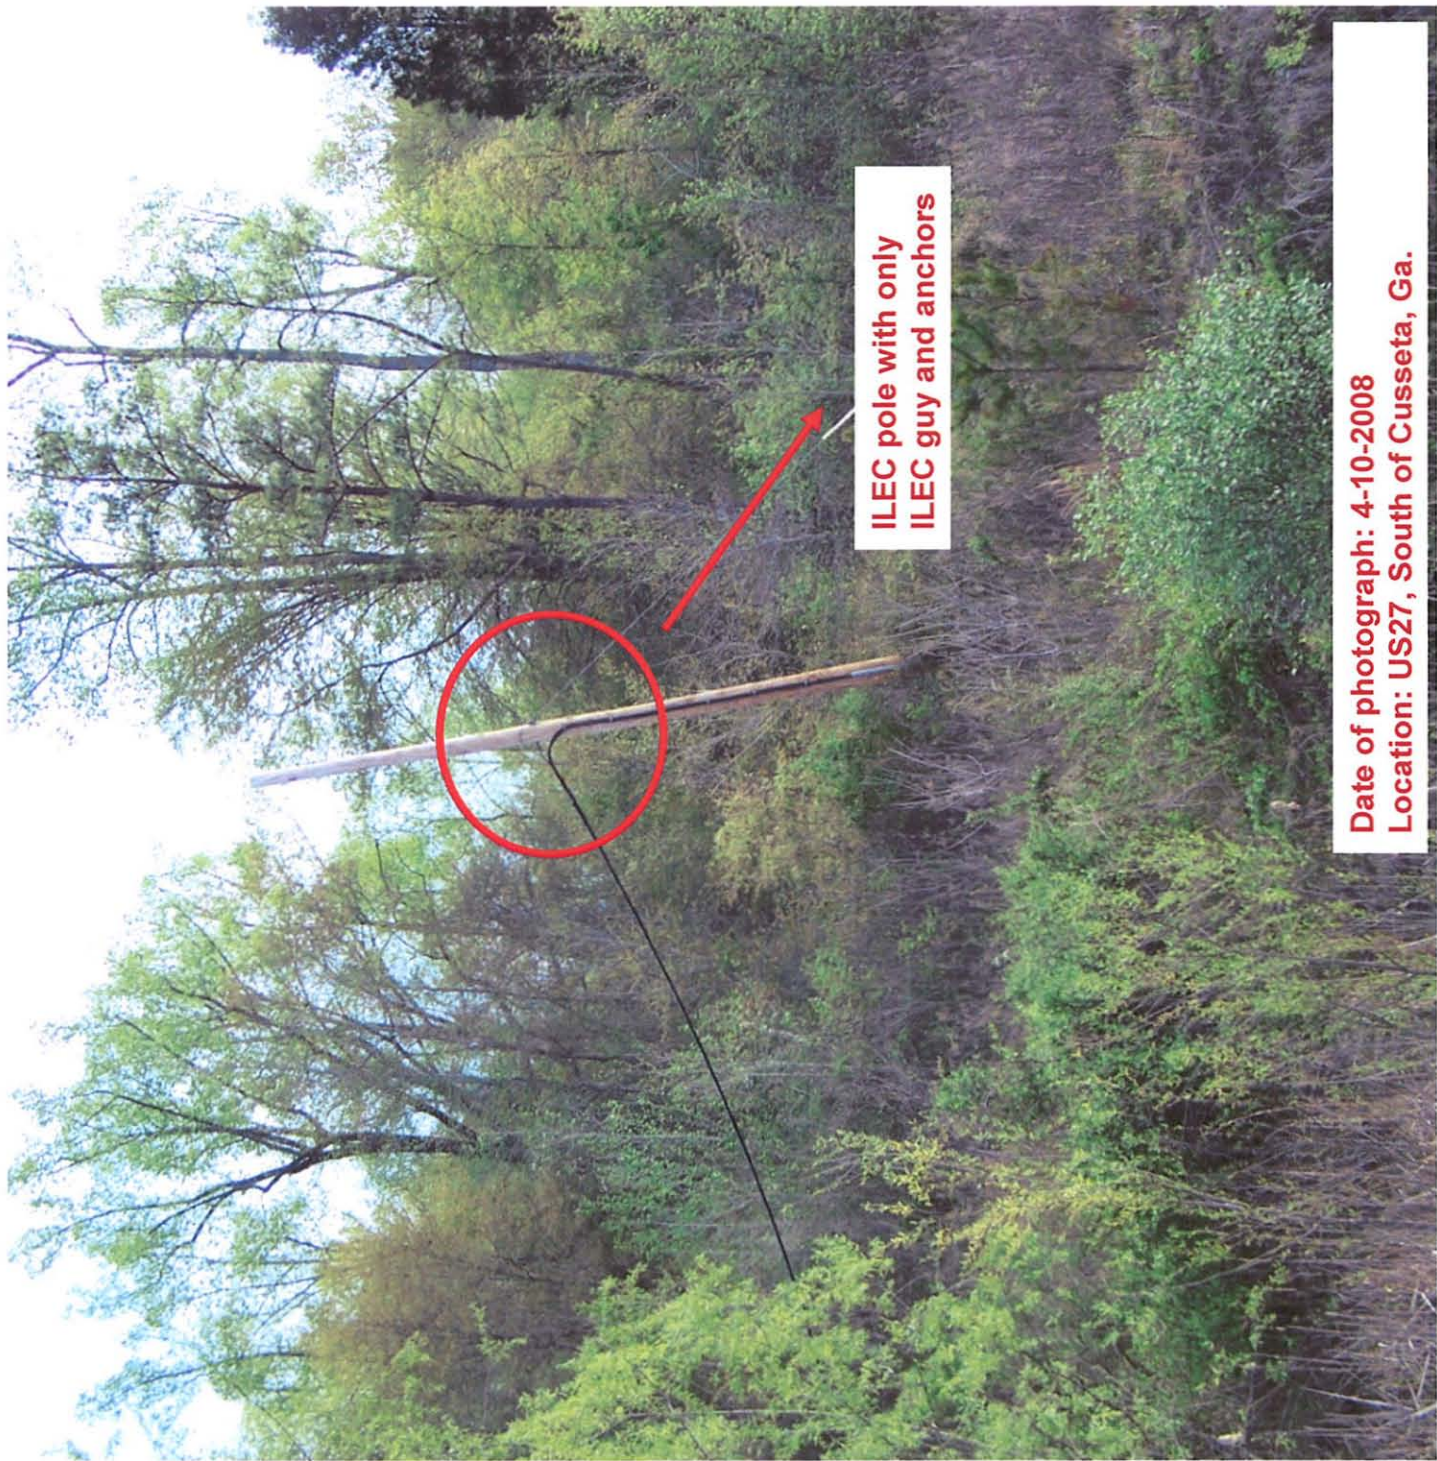
Date of photograph: 4-10-2008
Location: US27, South of Cusseta, Ga.

ILEC pole with only
ILEC guy and anchors

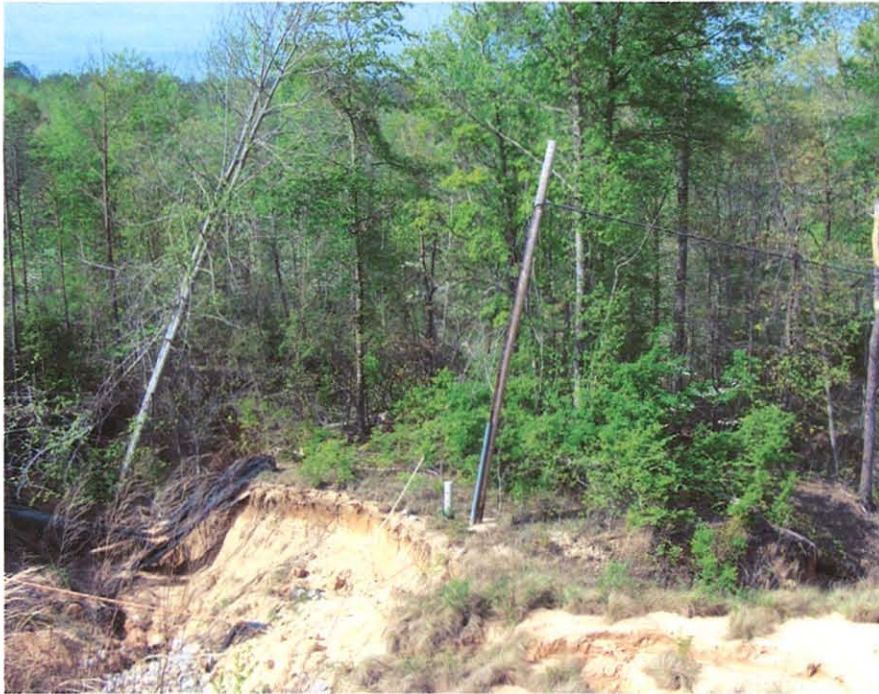
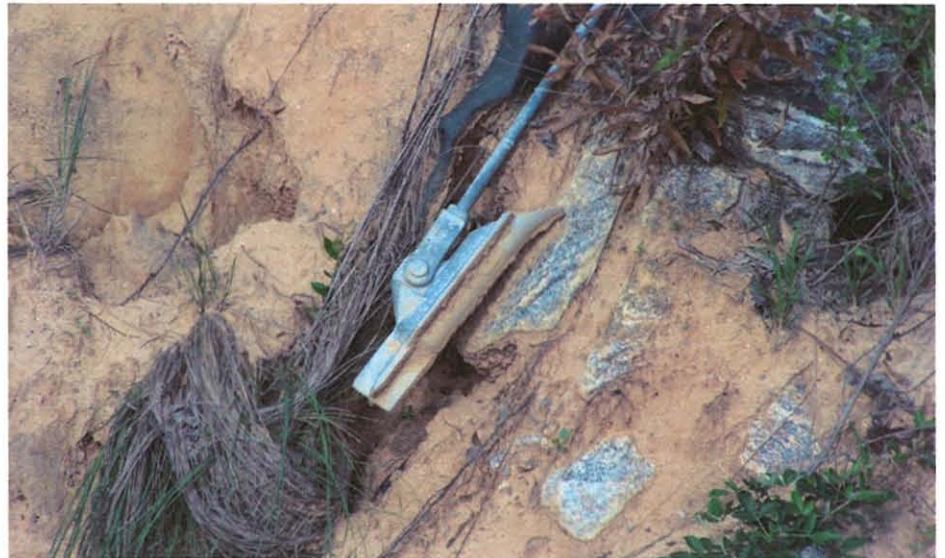
**Date of photographs: 4-10-2008
Location: US27, North of Lumpkin, Ga.**

**ILEC pole with ILEC guy and anchors
improperly installed in loose, sandy soil**

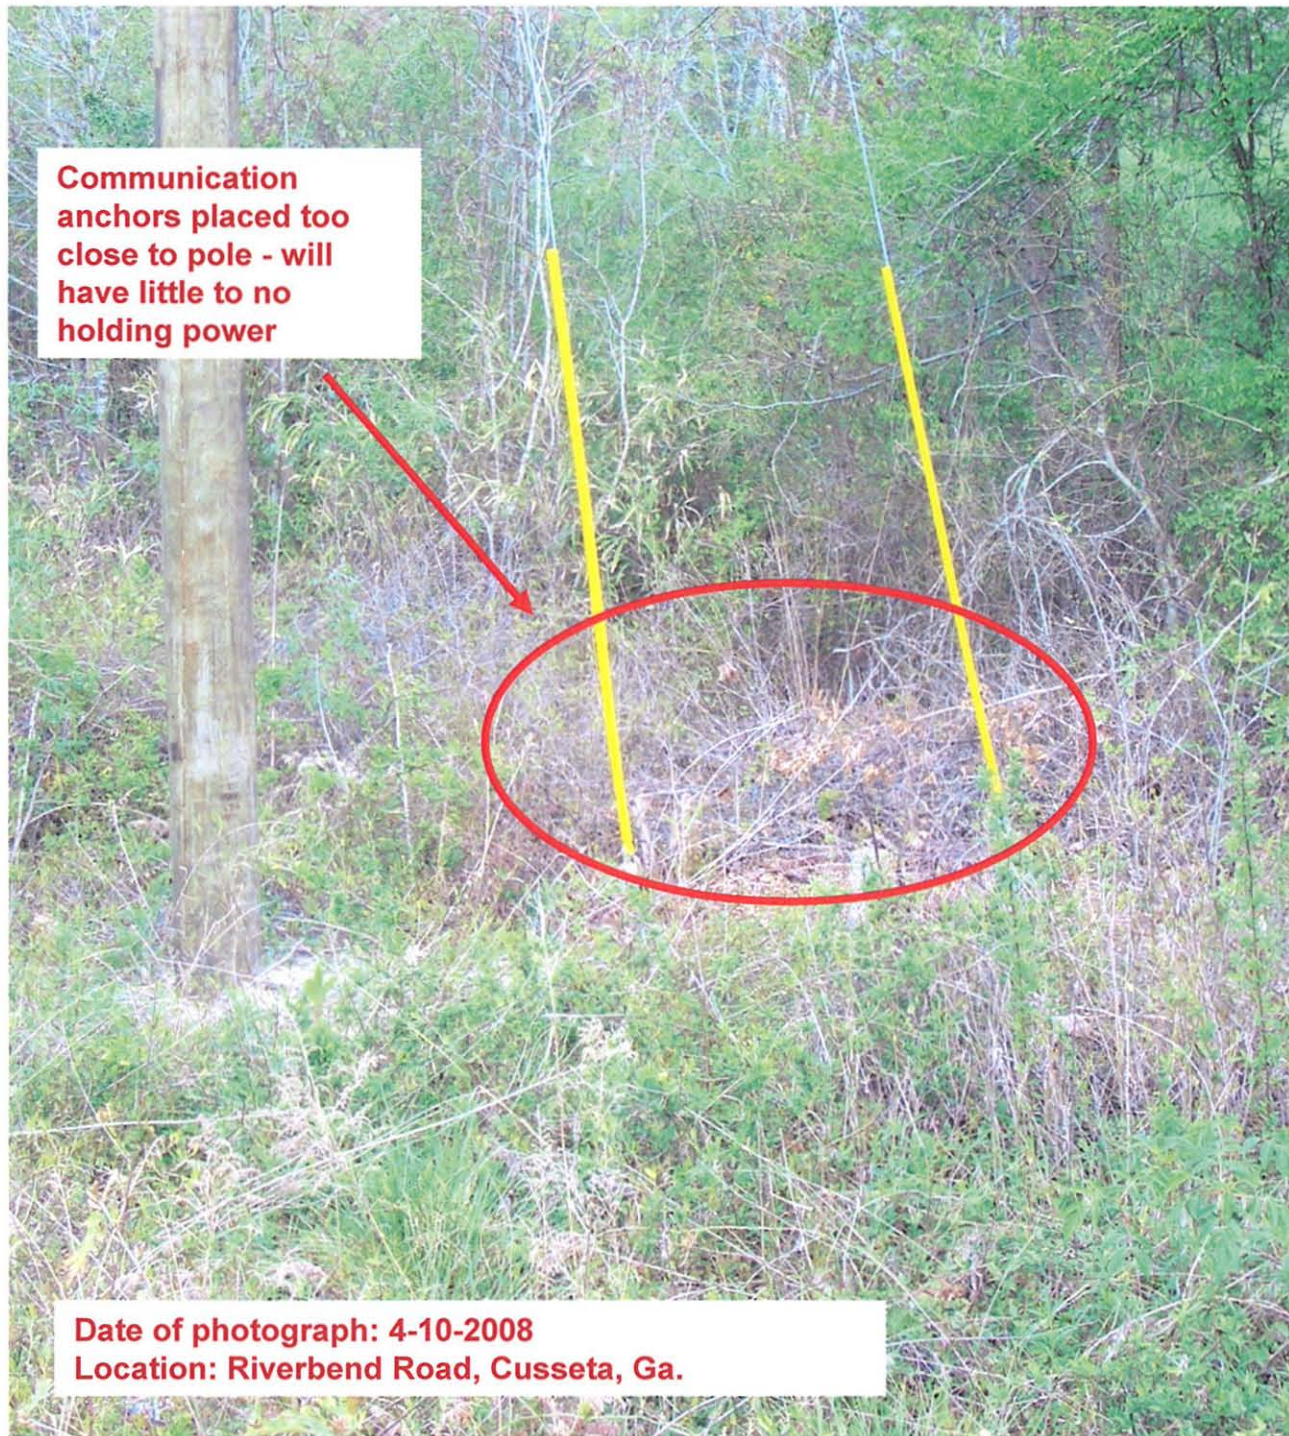
Date of photograph: 4-10-2008
Location: Riverbend Road, Cusseta, Ga.

Communication
anchors placed too
close to pole - will
have little to no
holding power

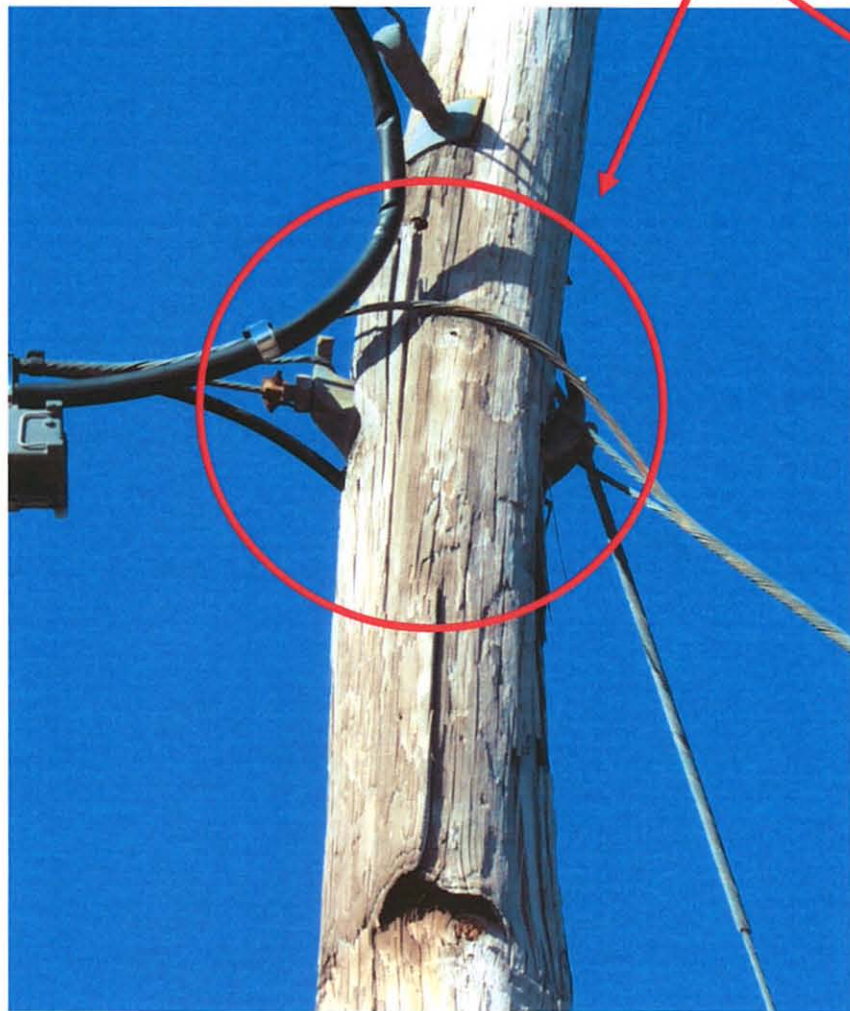
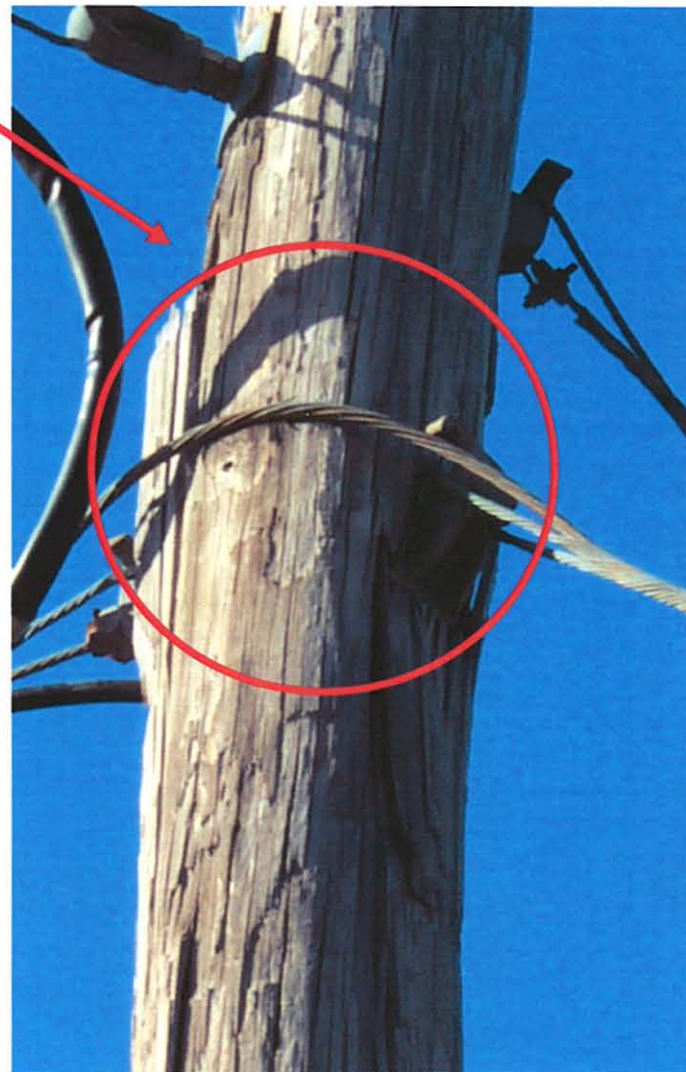
Date of photographs: 2003
Location: Ga Hwy 26, East of Cusseta, Ga.

Excessive ILEC guy wire tension crushing pole

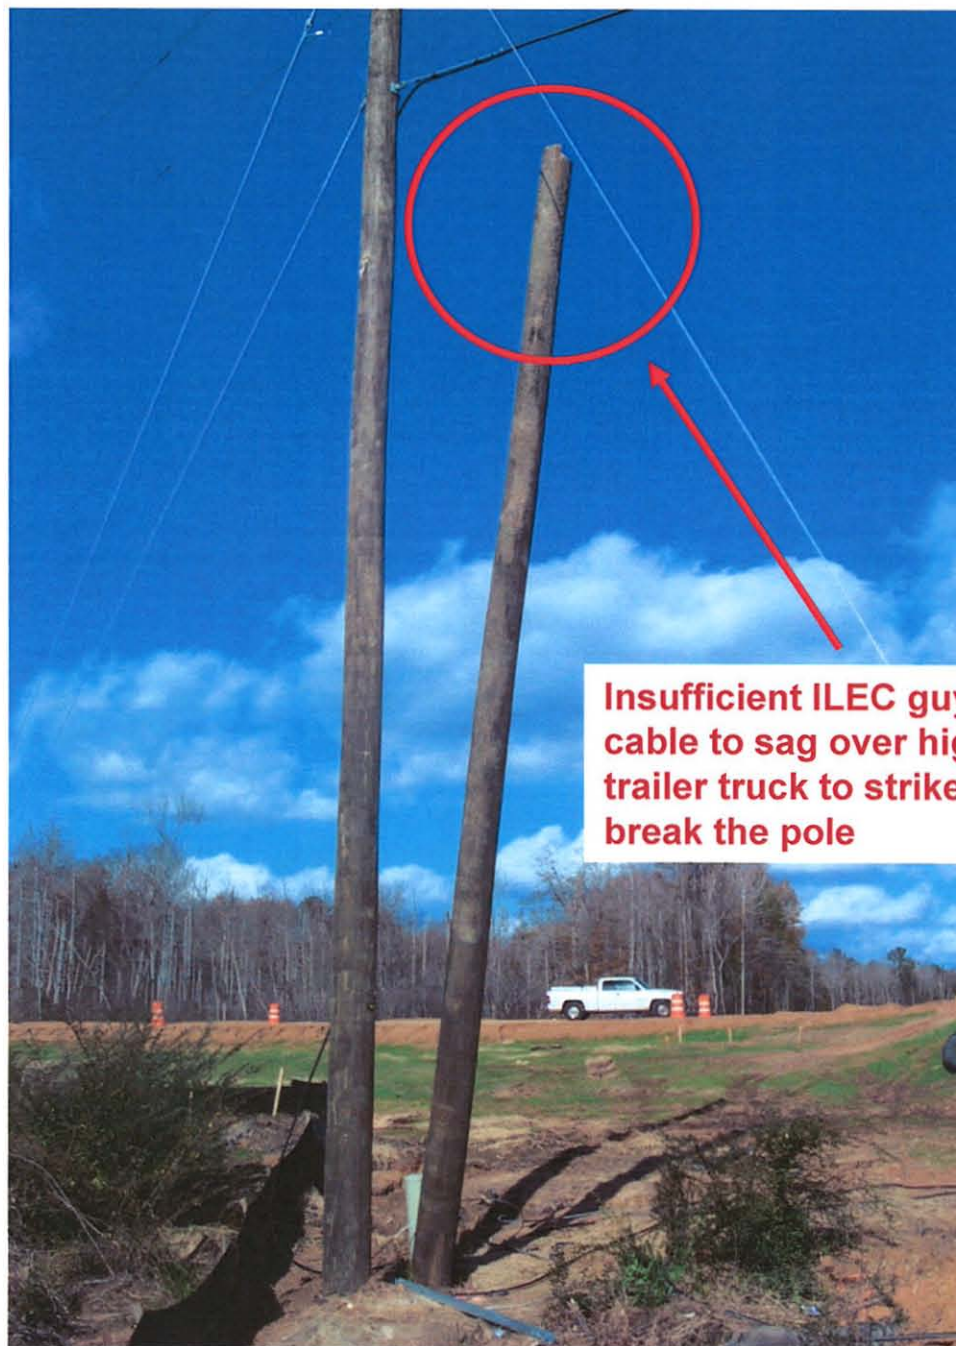
**Date of photograph: 12/20/2002
Location: US27 at Marlette Drive, Cusseta, Ga.**

Insufficient ILEC guying caused ILEC cable to sag over highway and tractor trailer truck to strike the cable and break the pole

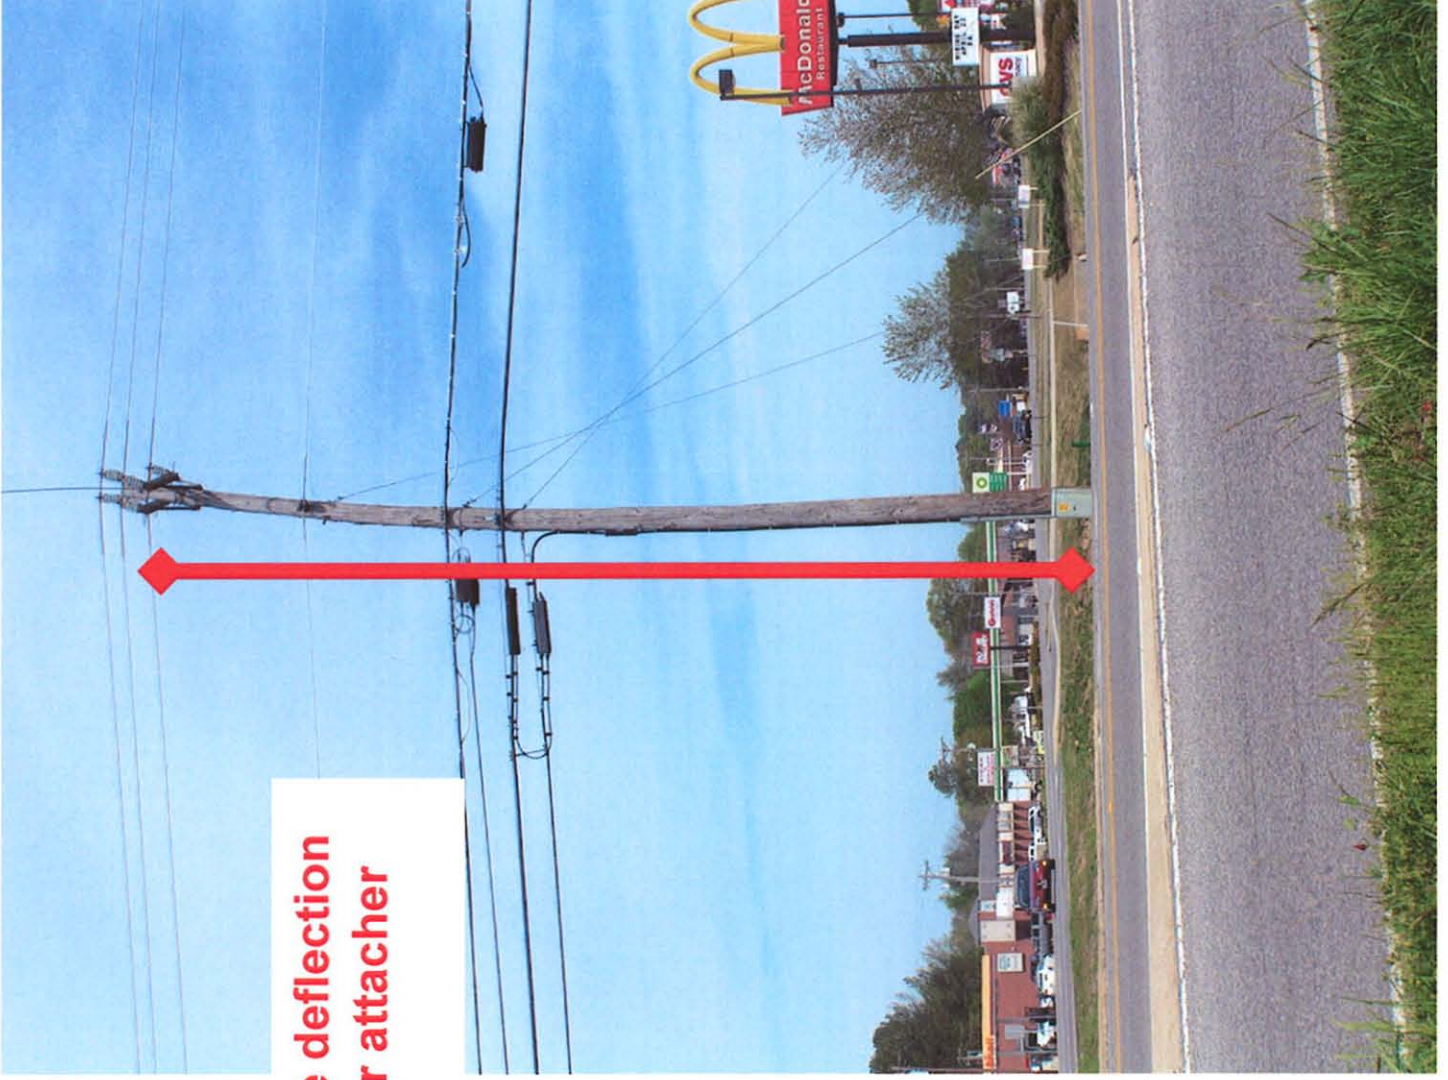
remain upright and they are critical components of the safety of individual poles and pole lines. When anchors and guys are not properly installed, or not installed at all, the balance and strength of the poles to which they are attached (or not attached) will, of course, be negatively impacted, causing pole deflection (or bending) and pole failure during storms. See Tab 1, Photographs 1-3.

**Significant pole deflection
due to improper attacher
guying**

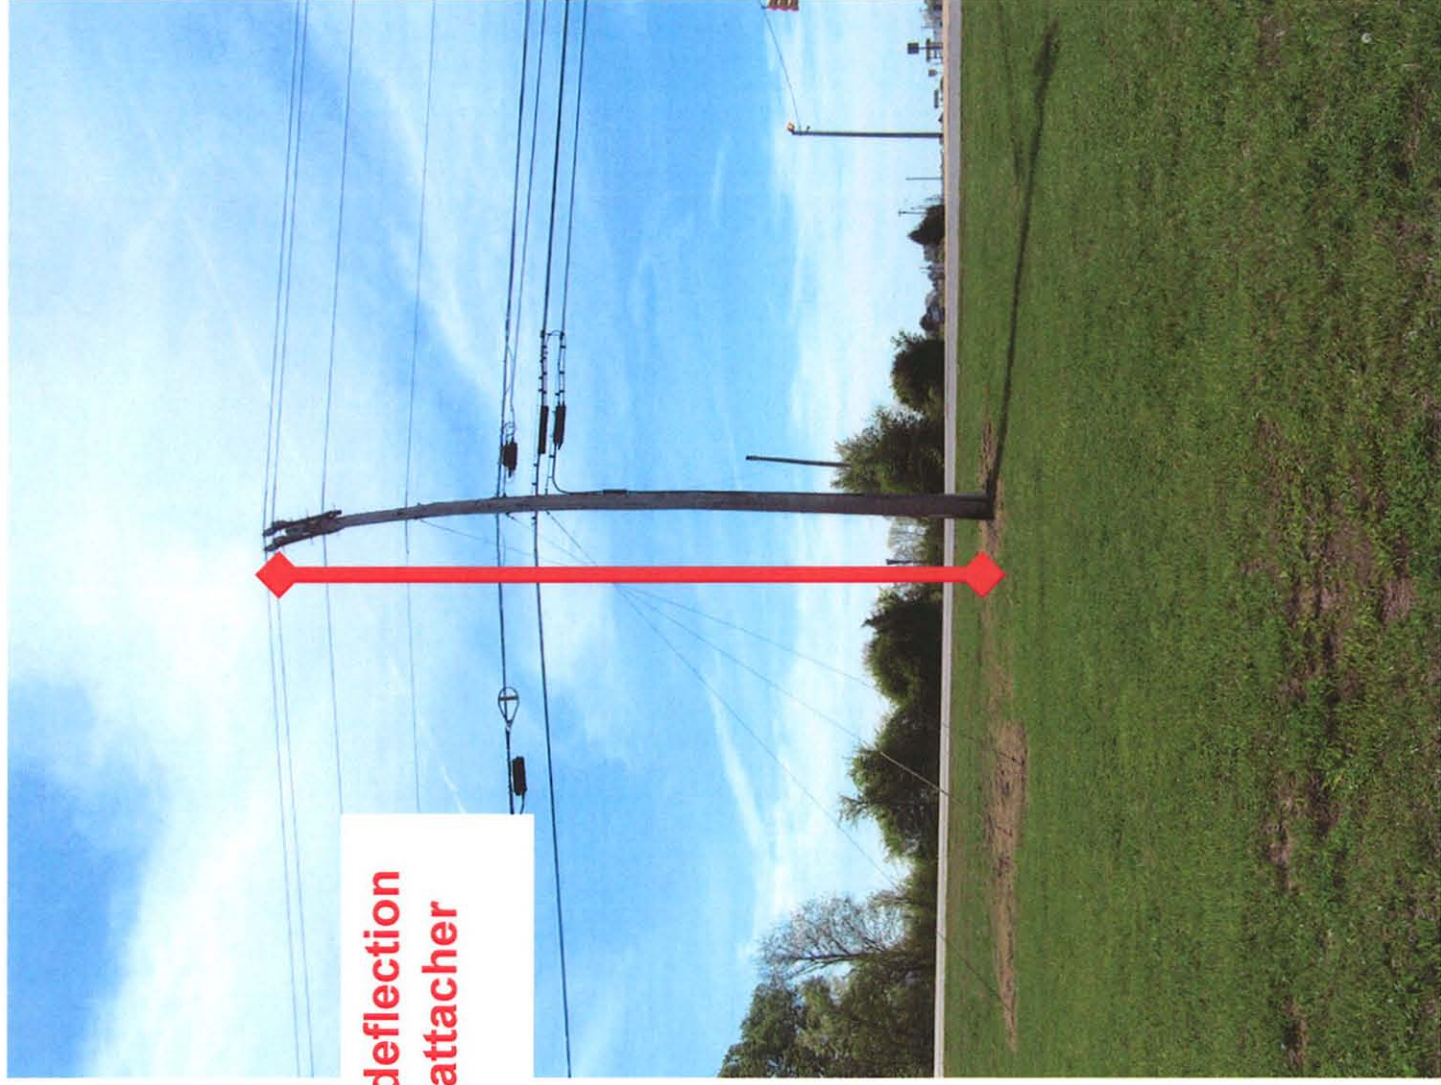
**Significant pole deflection
due to improper attacher
guying**

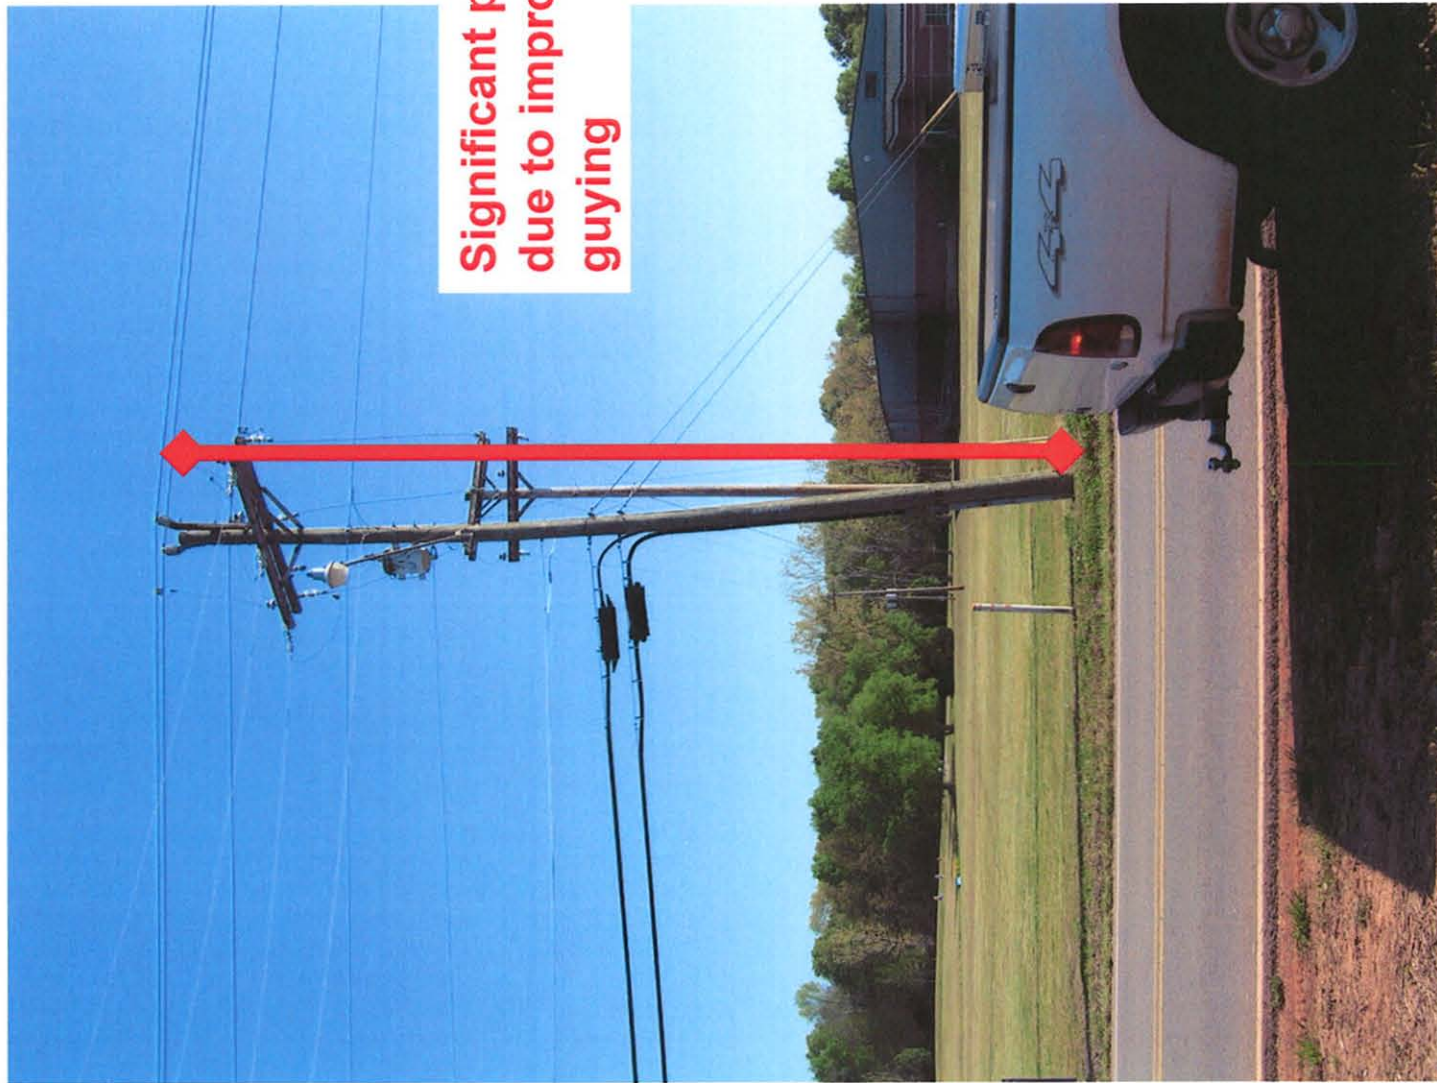
**Significant pole deflection
due to improper attacher
guying**

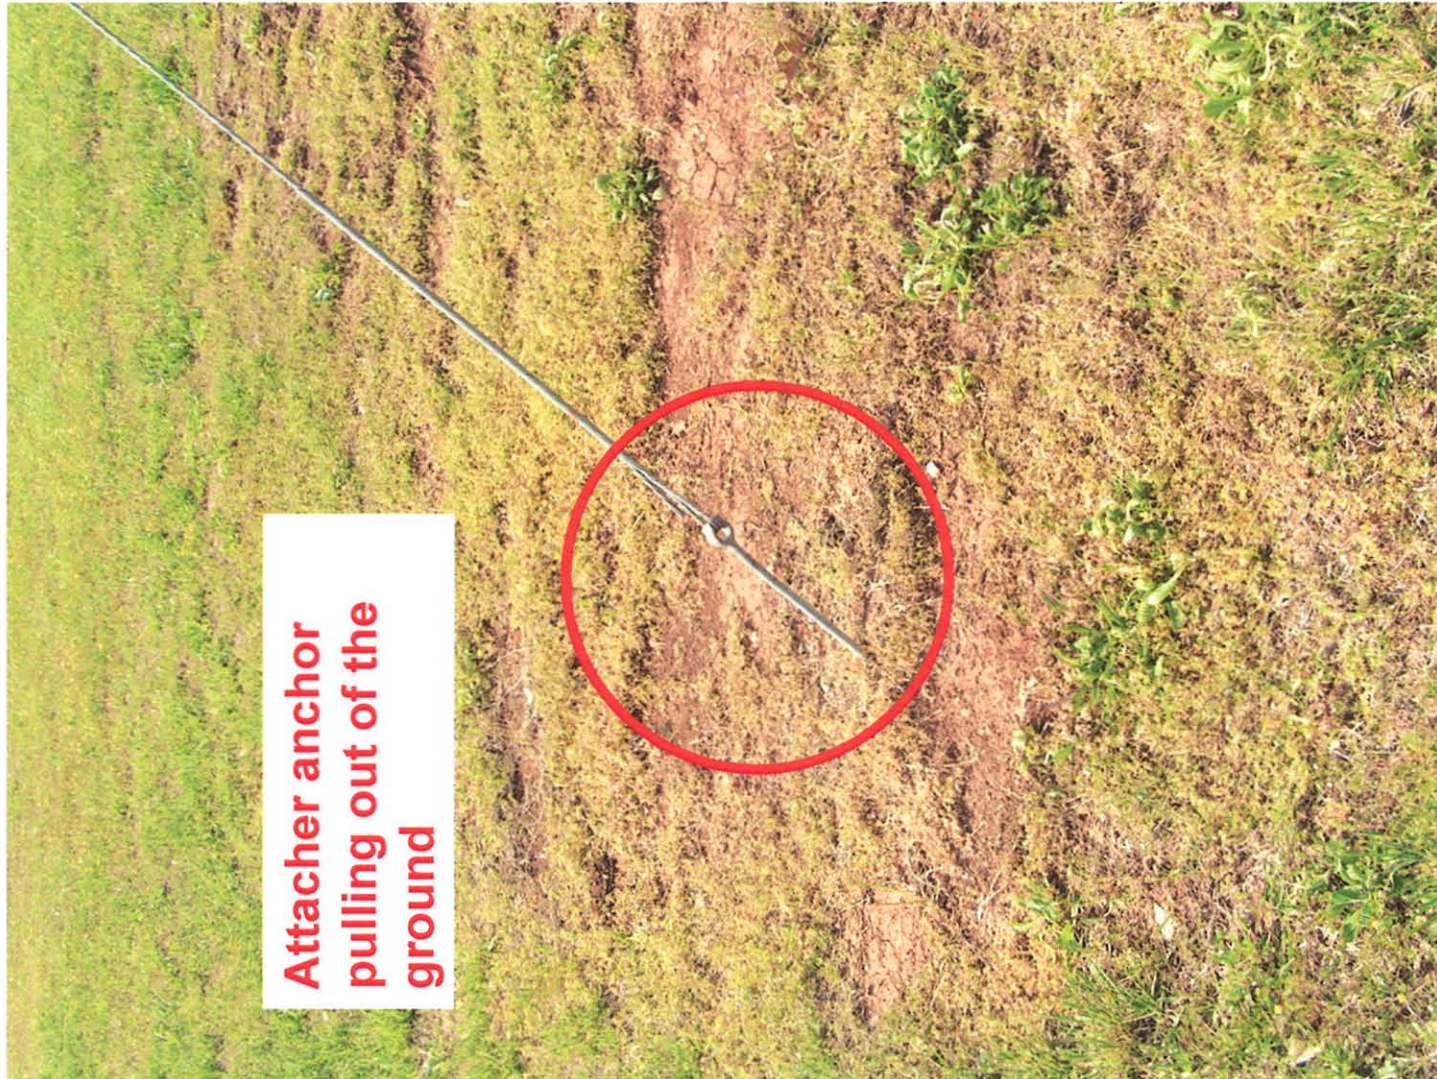
**Attacher anchor
pulling out of the
ground**
